MATERIAL PERFORMANCE INVESTIGATION ON THE FAILURE OF AN AIRCRAFT (ABT-18) NOSE WHEEL STRUT

ABSTRACT

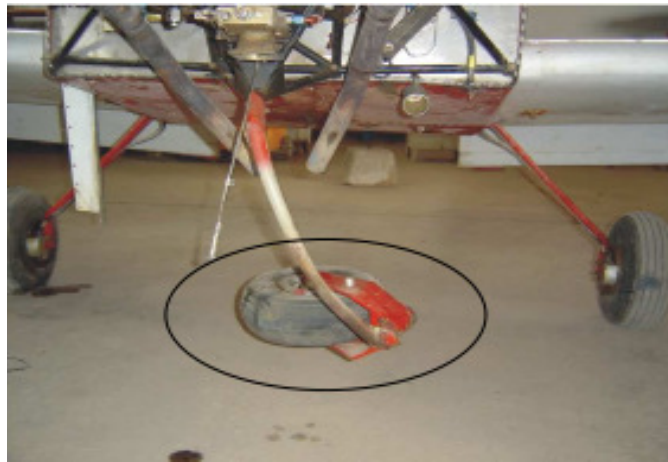
Plate 1: The Failed Strut

The landing gear comprises of the nose wheel as depicted by the circle and two main landing gear assemblies. The nose wheel of the ABT-18 aircraft is designed to be equipped with spring steel shock absorbers underlain with wood and wrapped with fiber glass fairing while the former trainer aircraft such as Piaggio and Bulldog makes use of oleo-pneumatic shock absorbers.

It has been observed that during the years of conducting flying training, several incidents have been recorded whereby the nose wheel strut failed particularly during hard landings. These incidents had resulted in severe damage to the propeller, engine, airframe and sometimes injury to Pilots. This in turn contributes to delays and disruption of Pilot trainings. Since the ABT-18 aircraft is for training purposes, hard landings cannot be ruled out.

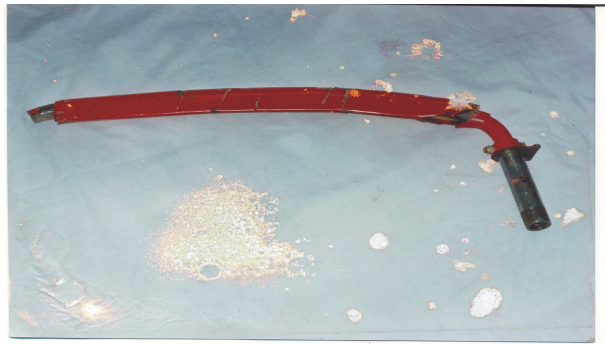
Plate 3: As-Received Failed Sample, F

Visual inspection via unaided eye showed a buckled and fractured strut material with V-shaped markings (Chevrons) on the fracture surface. It showed that the markings converge to the origin of the fracture.

Based on the aforementioned, it can be concluded that inconsistent design details and improper material specification may be the cause of the variations present in the chemical composition of both samples. The buckling may have occurred as a result of the insufficient shock absorbing property of the nose wheel strut material.

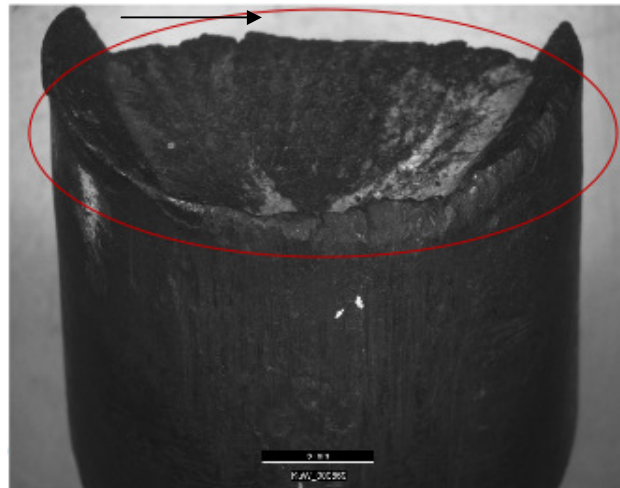
Plate 4: The Fracture Surface

The fractograph is presented in Plate 4. It shows incidence of a ductile pull and high energy fracture. This is evident by the cone shape of the fractograph and the observed tear, depicted by the circled part. Further investigation of plate 4 reveals no evidence of hole. This nullifies the assumption that a hole may be the cause of failure. However, it is worthy of note that a hole is not seen, the presence of micro-pores might be associated with the high energy fracture. More so, the

presence of chevrons is characteristic of brittle fracture associated with fatigue. This kind of failure produces no gross but very little mass deformation. Such a fracture is sudden, thus produces disastrous consequences [5].

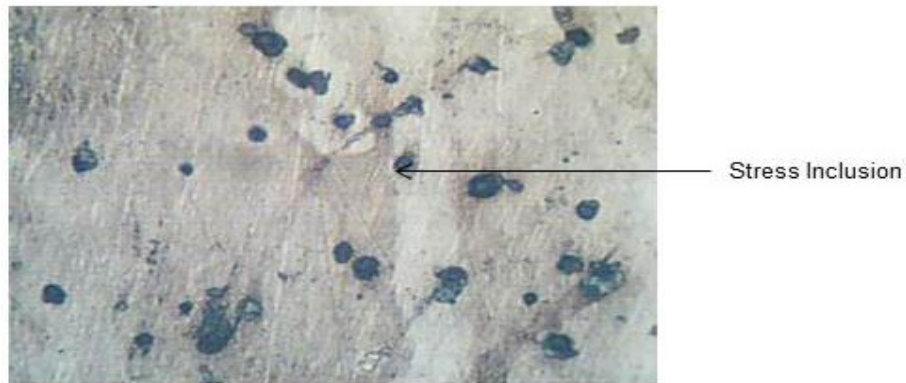
Plate 5: Optical View of Undamaged Strut Sample at X200

Microstructural examination of the both samples at magnification of X200 shows pearlite in ferrite matrix and the presence of inclusions, which are more predominant in the structure of the failed strut, hence; resulting into pitting. Some of them are seen as degenerated inclusions. The inclusions acted as stress raisers and fatigue initiation sites which eventually culminated into fatigue cracks and final fracture.

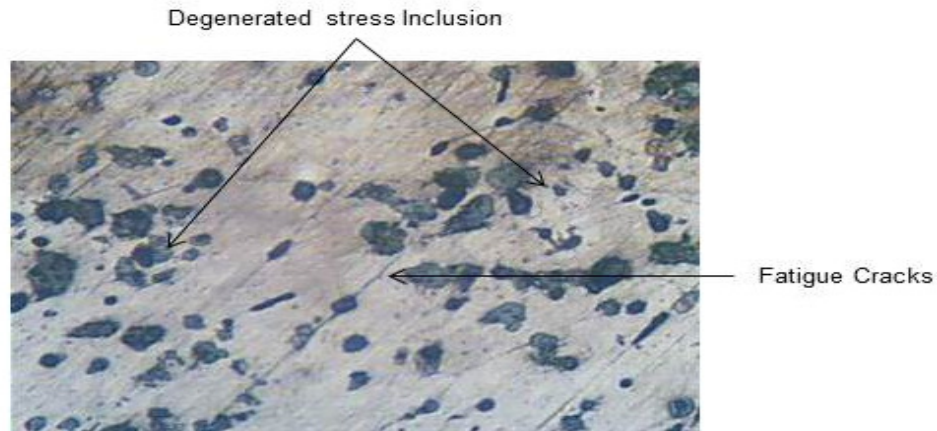
Plate 6: Optical View of Failed Strut Sample at X200 Showing Fatigue Cracks
